Special Report 77-29

# INFRARED THERMOGRAPHY OF BUILDINGS

## Qualitative Analysis of Window Infiltration Loss

Federal Office Building, Burlington, Vt.

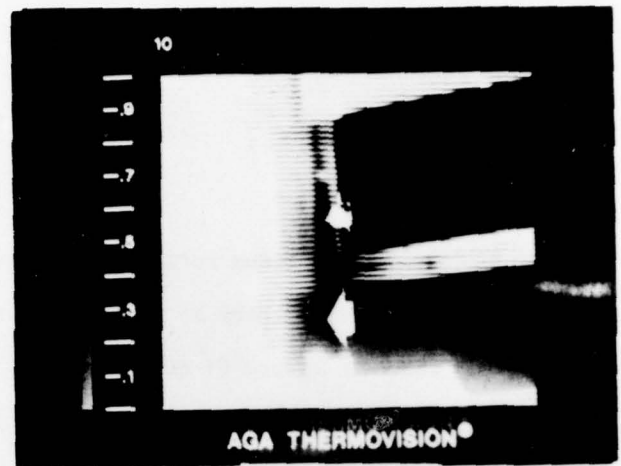
Figure 2.

Figures 1 and 2 show thermograms of two north-facing windows in Room 621 taken from inside the building. The infiltration (arrows) seen around these windows is typical of the condition observed at all of the randomly selected windows during the thermographic inspection of this building. Note that in Figure 2 the infiltration is more extensive than in Figure 1. The horizontal black line between the two arrows in Figure 2 shows cold

air leaking through the seal at the top of the opening window. Generally speaking, the air leakage at this location was not as severe as it was around the framing space of these windows. Figure 3 is a photograph of three windows in Room 621.

Figure 4 is a thermogram of the top left part of another projected window in Room 621. Note that air leakage at the window opening is minimal compared with leakage through the window framing space. Also, note in the three thermograms shown in Figures 1, 2 and 4, and in all subsequent ones, that the aluminum frames do not constitute a source of heat loss quite as severe as the infiltration losses.

When air leakage around windows is a major problem, as it is in this building, there are several possibilities for correcting the situation. One corrective action would be to improve the glazing seals in all of the windows, recaulk the windows and add fiberglass or foam insulation around the framing space of each window. Obviously this approach would involve a labor intensive solution that, while significantly reducing the overall heat loss through infiltration, would have no effect on the heat loss by conduction through the single-pane glass. Another approach would be to remove all existing windows and install double- or triple-glazed windows throughout. When the new windows are installed, the framing spaces could be heavily insulated to reduce excessive air leakage. This second alternative would be both labor and capital intensive but would result in an even greater reduction in the overall heat loss around and through each window.

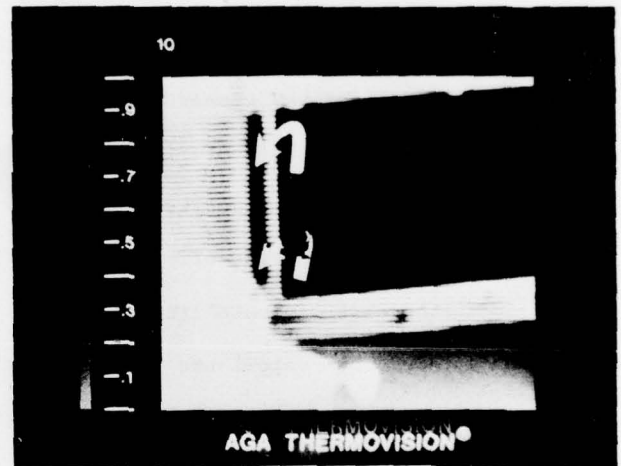
Figure 4.

Figure 5 is a thermogram of cold air leakage under the frame of the opening sash of a window in Room 621. This leakage is probably due to a deficiency of caulking, whereas in the previous three thermograms (Figs. 1, 2 and 4) lack of insulation in the framing space results in excess heat loss.

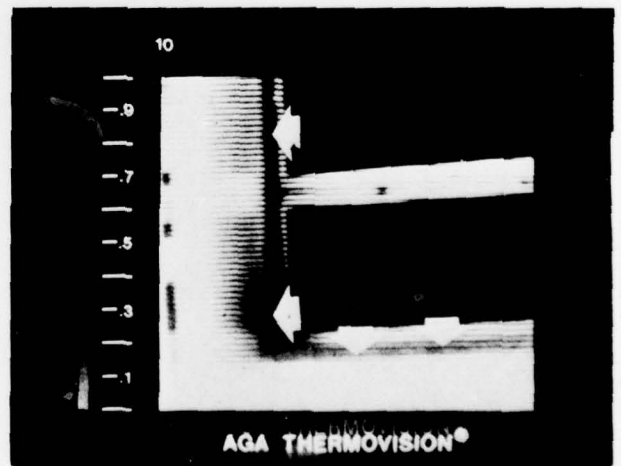
Figure 6.

Figure 6 is a thermogram showing the comparative difference between the heat loss through the framing space (horizontal arrows) and the heat loss under the frame of the opening window (vertical arrows). In this situation, there is more heat loss through the framing space than under the window frame.

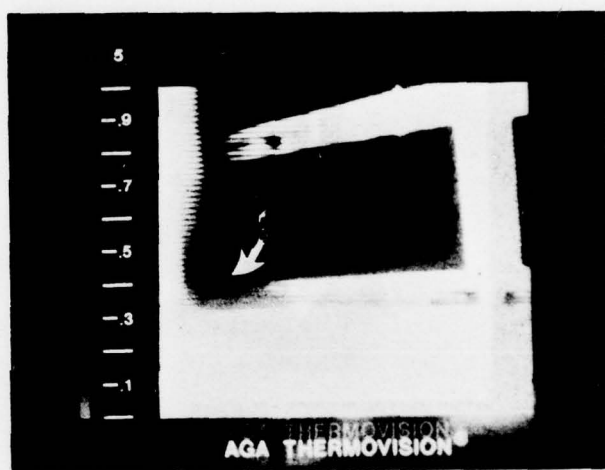
Figures 9 and 10 are thermograms of two north-facing opening windows in Room 629. The arrows identify excess air leakage entering the room through the interface of the glass and aluminum frame. As in the case of Figure 8, the heat loss around these windows could be due to an inadequate glazing seal. Figure 11 is a thermogram of the lower left corner of another window in Room 629 having a situation similar to those in Figures 9 and 10.

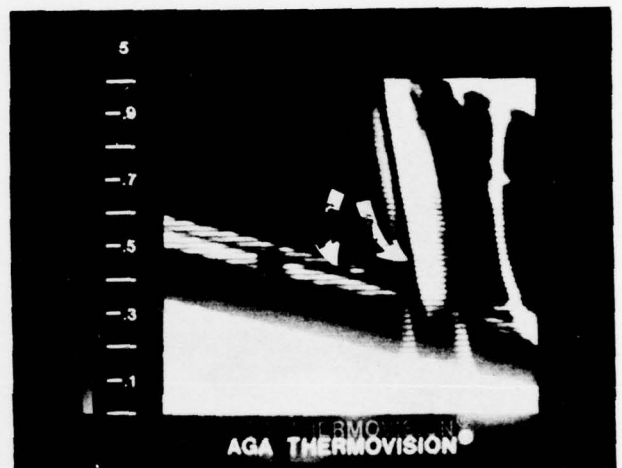
Figure 22.

Figure 22 is a thermogram of two other south-facing windows in the Post Office workroom. The arrows identify the usual sources of heat loss found in all the other windows inspected during this survey. However, the general appearance of the thermal pattern of the window on the right indicates why it is so cold working near these windows.

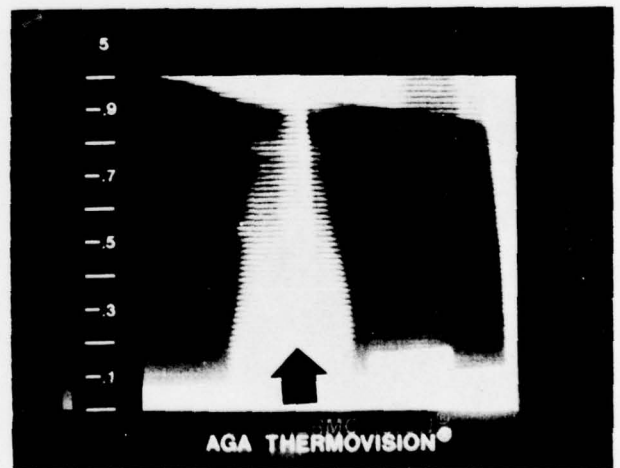
Figures 23 and 24 are thermograms of the lower sections of the east-facing stationary single-pane windows in the Post Office lobby. Arrows identify a plume of heat rising from the convectors directly under these windows. Figure 25 is a thermogram of the top section of one of these windows. The arrows locate the warm spots on the glass due to the heat rising from the convectors. Figure 26 is a photograph of these windows.

The discussion relating to the windows considered the retrofit options for all of the projected windows which opened. However, referring to Figures 23, 24, 25 and 27, we see that significant heat losses are occurring through the stationary windows in the Post Office lobby. To effect a significant reduction in heat loss, two possible corrective actions can be taken: 1) reduce glass area according to our previous recommendations or 2) retain the same glass area but install double- or triple-glazed windows. In either case, we also recommend that 1) aluminum reflectors be placed behind the convectors to deflect the heat back into the lobby, 2) heavy lined drapes be used during all non-occupancy hours, and 3) the temperature in the lobby (and in the whole building) be maintained at 68°F during occupancy hours, and reduced to 65°F at night.

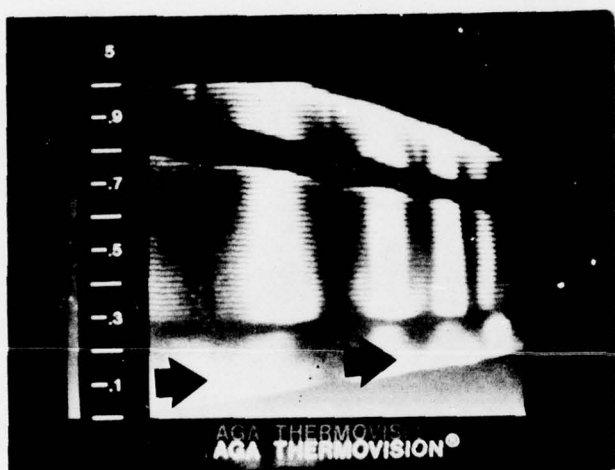
Figure 27.

Figure 27 is a thermogram taken directly outside the Post Office lobby; thus it can be compared with Figures 23-25. This thermogram proves beyond a doubt that the plume of heat is being readily conducted through the single-pane glass. Also note that the convectors themselves are transmitting heat (arrows) directly through the masonry wall. Figure 28

Figures 27 and 28 show evidence of excessive wall heat losses through the lower part of the east-facing wall (Post Office lobby) and the lower part of the south-facing wall (Post Office workroom). While the area involved is not extensive, these losses could be up to 5% of the total BTU loss of this building.

If aluminum reflectors can be inserted behind the convectors in the Post Office lobby so that they extend to the floor level, the situation shown in Figure 27 can be greatly remedied. However, a better solution can be achieved to reduce the wall heat losses shown in Figure 28. The wall can be insulated using various methods. If an approved finishing material is used for covering and fire codes permit, urethane could be sprayed on the wall. Urethane has the highest thermal resistance (R) factor of any commercially available insulation. Other possibilities include the use of rigid urethane or Styrofoam, fiberglass insulation, and urea formaldehyde insulation. GSA management personnel will have to assess the trade-off between relocating pipes on or near this wall, and the cost of installing insulation with the savings that could be realized.

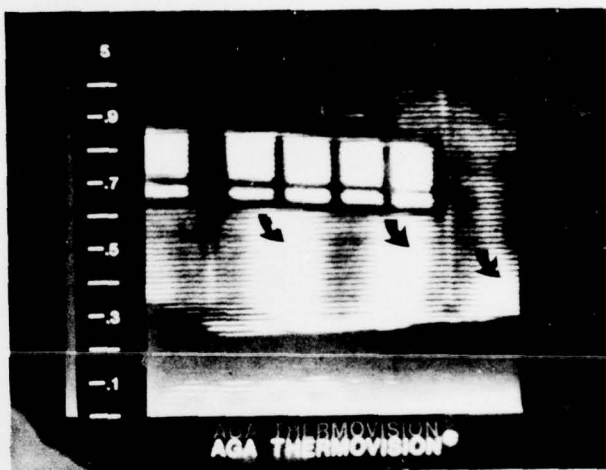
Figure 28.

is another thermogram showing heat being conducted through the masonry wall. This is the south-facing wall of the Post Office workroom where radiators and hot water pipes are mounted directly to the wall.
